A random audit of recent satellite antenna system installations was made during the last week of January and the first week of February, 2009. These audits were randomly selected from a list of over 3,000 installations. The purpose of this audit was to verify compliance with applicable installation requirements of the National Electrical Code (NEC) as required by Minnesota Statutes, Section 326B.35. The most critical of the NEC requirements that apply to antenna installations, both community antenna television (cable tv) systems and satellite antenna systems, are the grounding requirements. Department staff conducted audits of 147 installations in various locations within the greater twin city metro area. These locations included those in the inner city and suburbs, as well as outlying communities. Of the 147 systems that were audited, 97, or 66% included significant code violations, primarily lack of grounding or improper grounding. The attached pictures taken during the audit illustrate typical violations.

Satellite Dish Installation Audit Distr 2

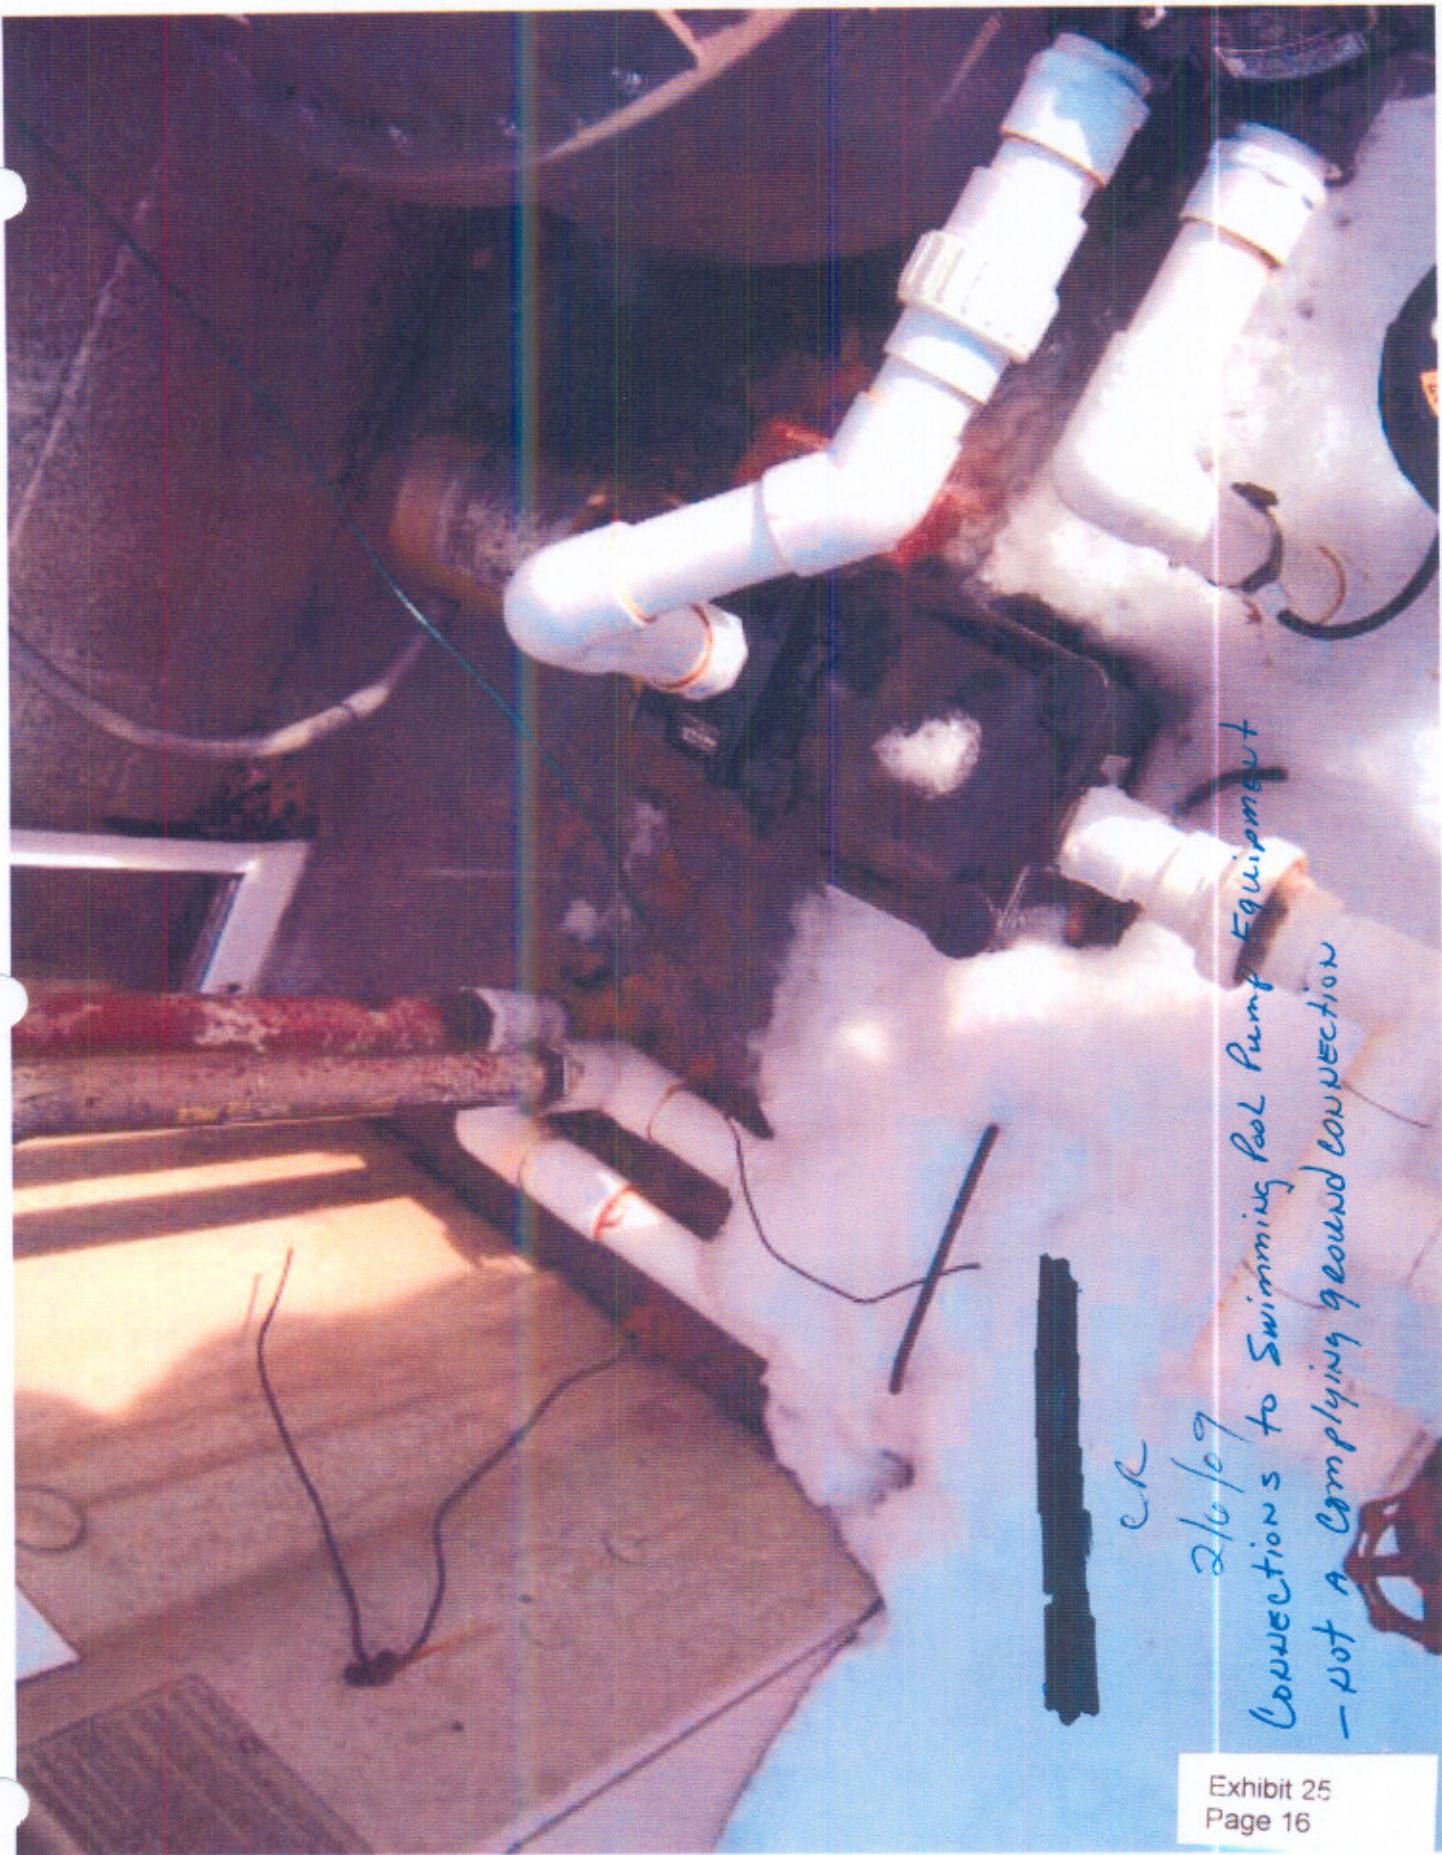
2/6/09
c.r.
Connections to Swimming Pool Pump Equipment
- not a complying ground connection

Connection to Air Conditioner Disconnect

- Not an approved grounding point
- grounding clamp not installed properly because it inter-fuses with access to disconnect

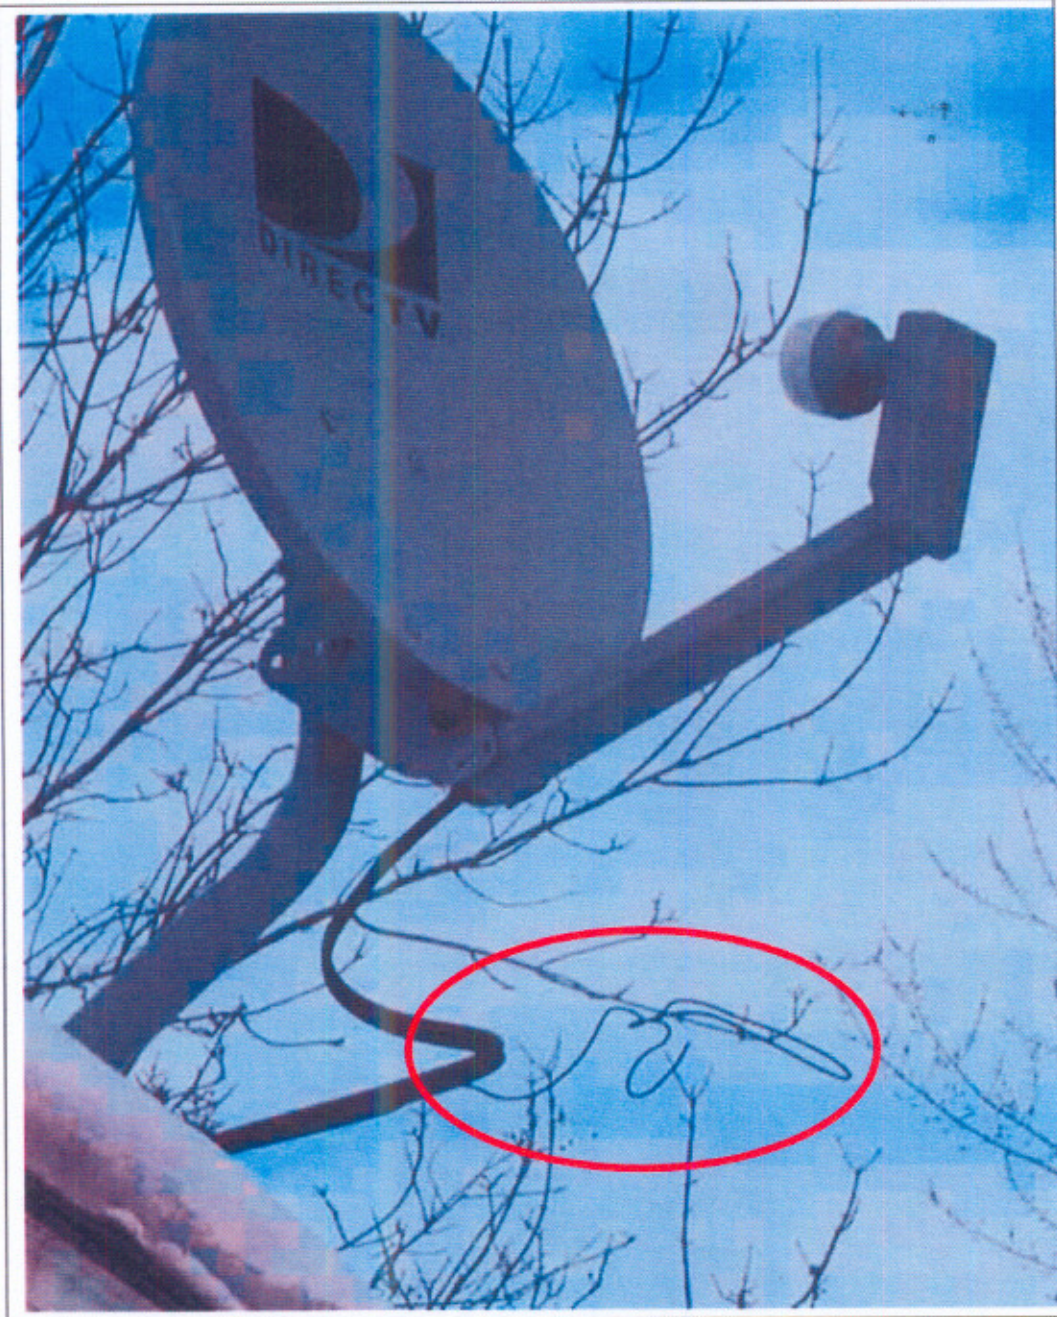
No grounding connection to Dish

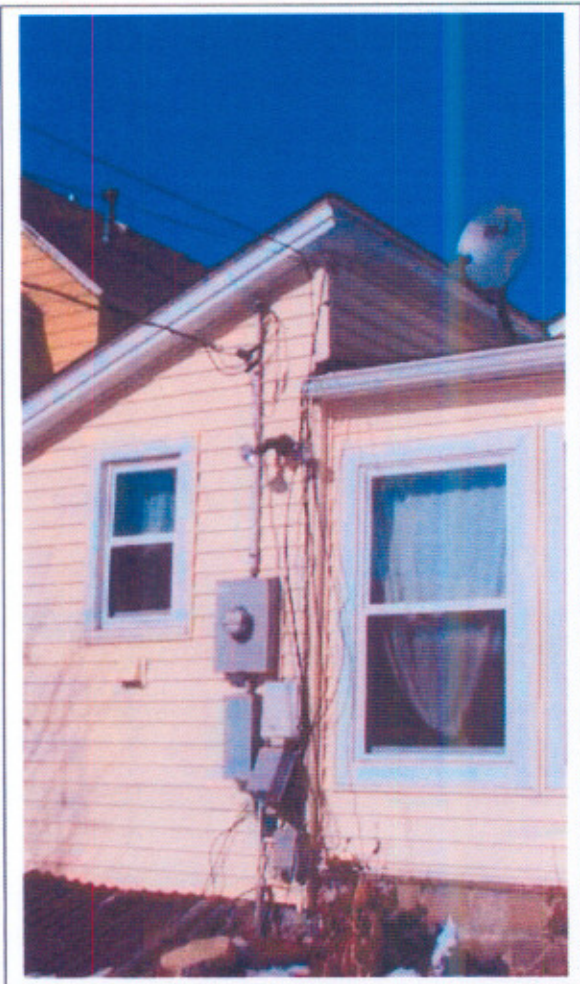
- 4-foot coil of stranded #10
- Wrapped around telephone company grounding electrode conductor at the split bolt connection
